Shenandoah Retirement Home Fire Roanoke County, Virginia

Shenandoah Retirement Home Fire Roanoke County, Virginia (December 14, 1989)

Investigated by: Randolph E. Kirby

**This is Report 038 of the Major Fires Investigation Project conducted
by TriData Corporation under contract EMW-88-C-2649 to the United
States Fire Administration, Federal Emergency Management Agency.**

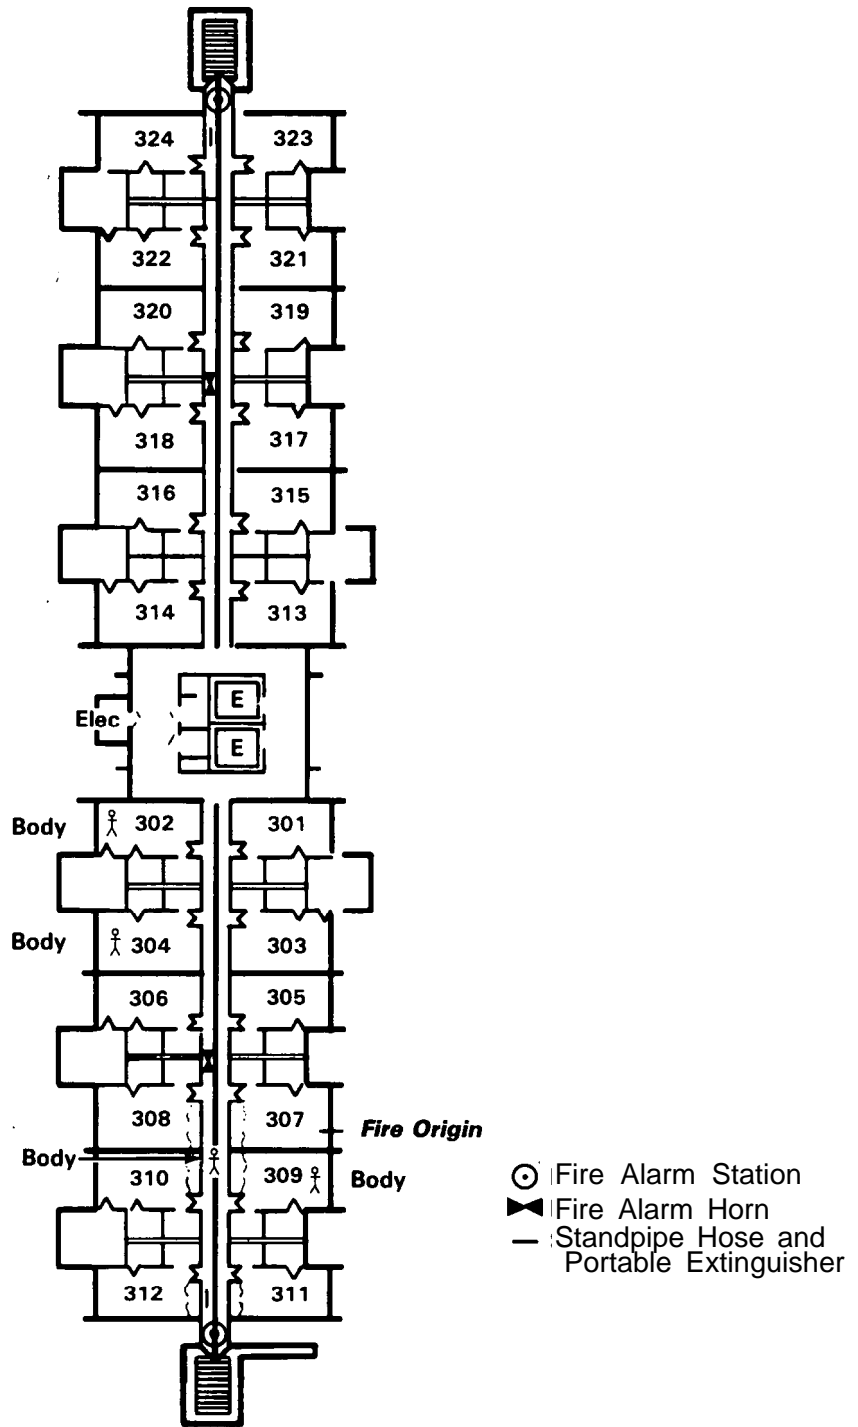
Shenandoah Retirement Home
Third-Floor Plan and Location of Fatalities

Four elderly residents from the third floor died as a result of smoke inhalation -- three women and one man, ranging in age from 79 to 87 years. The body of the resident of Apartment 307, (area of origin), who was confined to a wheelchair, was found in the hall a few feet south of his apartment door. One female victim of apartment 309 was found in her unit on the floor next to her bed. The third victim (female) was found in Apartment 302. The fourth victim, (female), was found in Apartment 304, between the rear of the television and the window. This person was actually having a telephone conversation with the fire dispatcher while fire operations were taking place in the building. She was provided with instructions by the dispatcher regarding covering her nose and putting towels under the apartment door. Meanwhile, the dispatcher was advising firefighters on the scene of the woman's situation and her location. Because of heavy smoke conditions and locked doors, rescuers were unable to locate her in time to save her (see Appendix A).

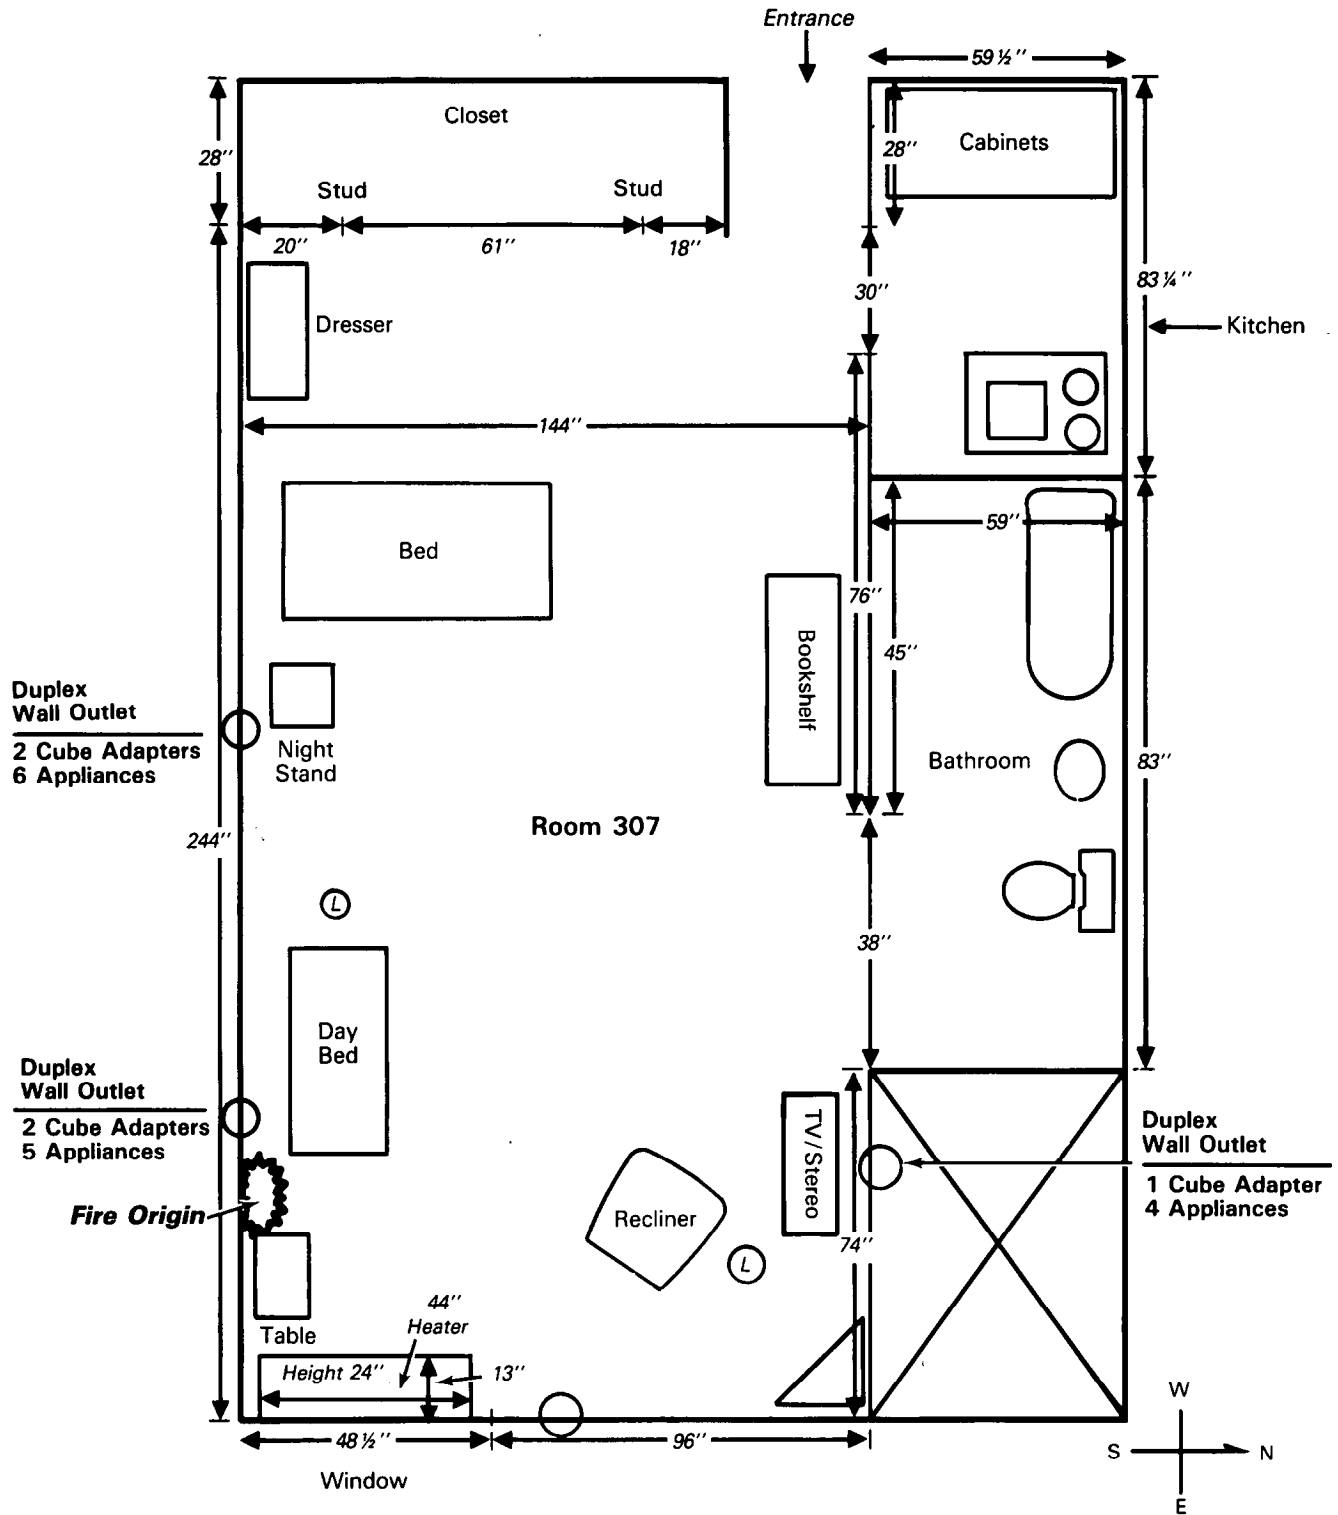
Room of Fire Origin

The fire originated in apartment 307 and is believed to be the result of an electrical overload which caused ignition of wood paneling; This particular one-room unit had 17 appliances of various types connected to the electrical receptacles provided for the unit (see Appendix B).

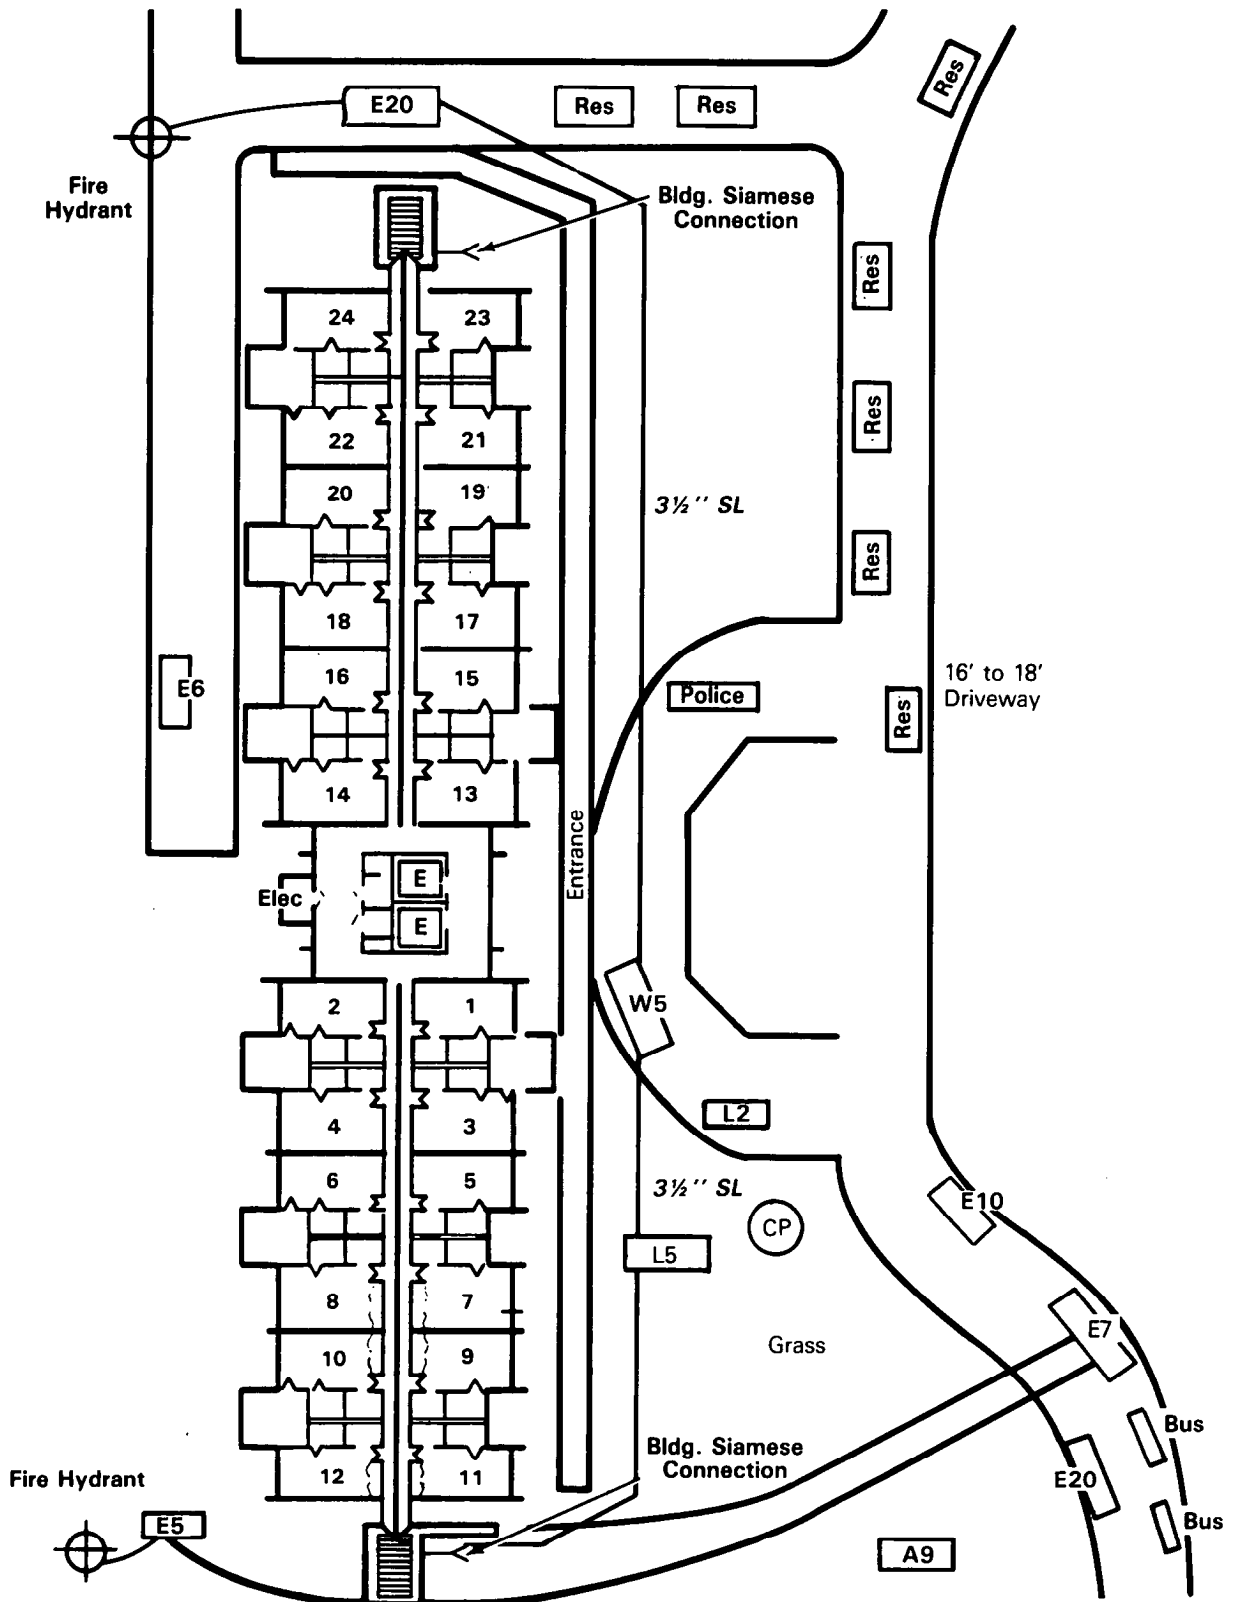
Fire Ground Diagram Showing Position of Fire Units at Scene

Emergency vehicle access is considered very poor, as space for vehicles near the building is extremely limited.

The emergency vehicle access designed for the Shenandoah Homes building is inaccessible at best. It only affords vehicle access to a very small portion of the structure and to one fire hydrant. This problem was most apparent when fire apparatus had to be placed on a snow-covered lawn in order to reach the building and to use the fire hydrant. A complete review of other existing structures that present similar problems should be taken without delay.
